PRINCE GEORGE REGION

TAKLA SILVER (Lustdust)

Property name: TAKLA SILVER (LUSTDUST)
Map number (see Appendix C): 49
Mine drainage sample numbers: LB00-3401 to 3403
MINFILE number: 093N 009

Date: September 25, 2000

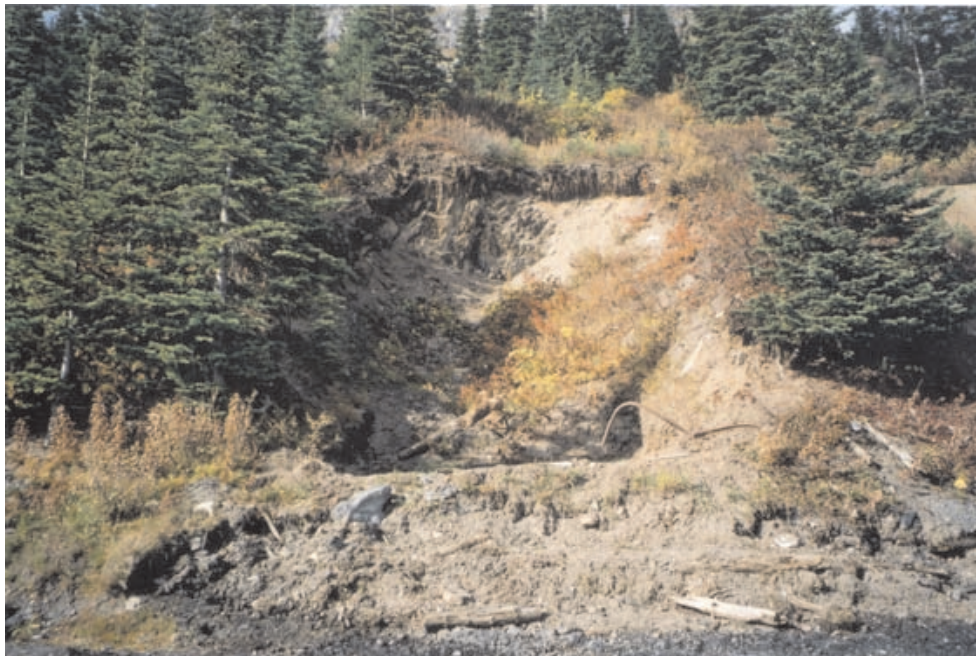
Two collapsed/backfilled portals adjacent to each other were previously draining water (K. MacDonald). No culverts were in place. Only the north adit was draining at the time and was sampled.

Photo 57. Backfilled portal at Takla Silver mine site.

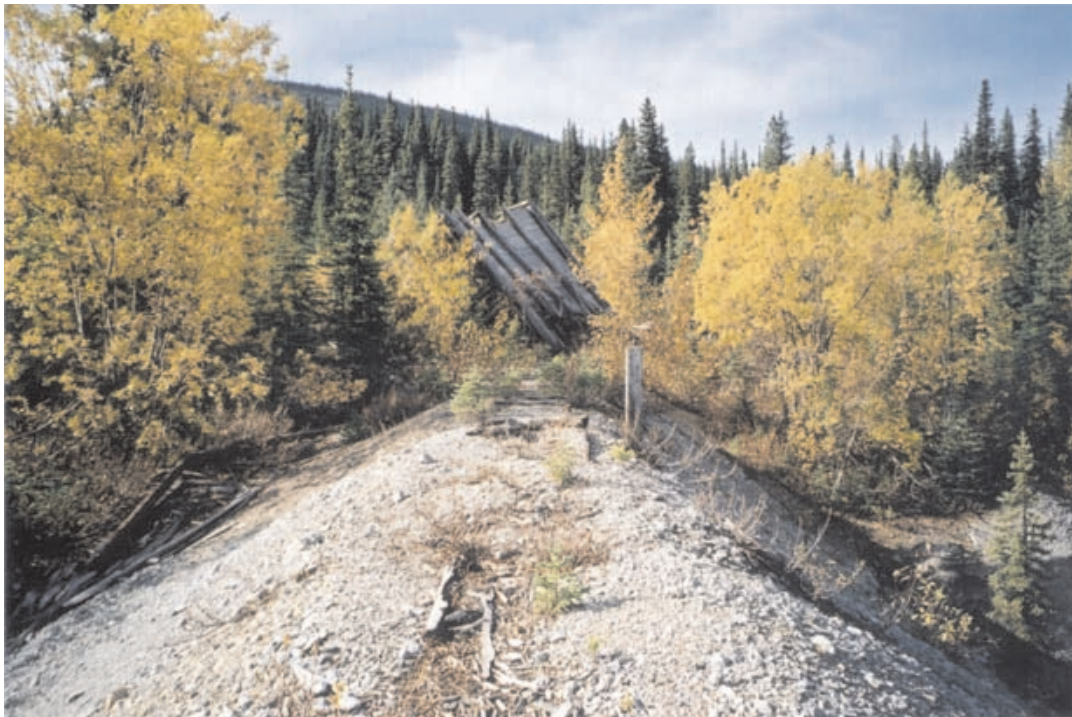
An open shaft and headframe are located at the north end of the mill complex. The headframe above the main shaft has collapsed on top of the shaft opening. However, the headframe timbers are unstable and alone, pose a hazard to public safety. The shaft is flooded - the water surface is about a 4 second drop. The water from the shaft was sampled. Dump cars and scrap steel noted in area.

The waste rock dump, directly south of the shaft/headframe is comprised of 3 fingers. The dumps are largely composed of limestone and massive crystals of calcite. The rocks are sparsely oxidized in patches to a brown-orange colour. The collective volume of the dump is in the order of 1800 m³.

Photo 58. Bralorne-Takla dump and shaft headframe.

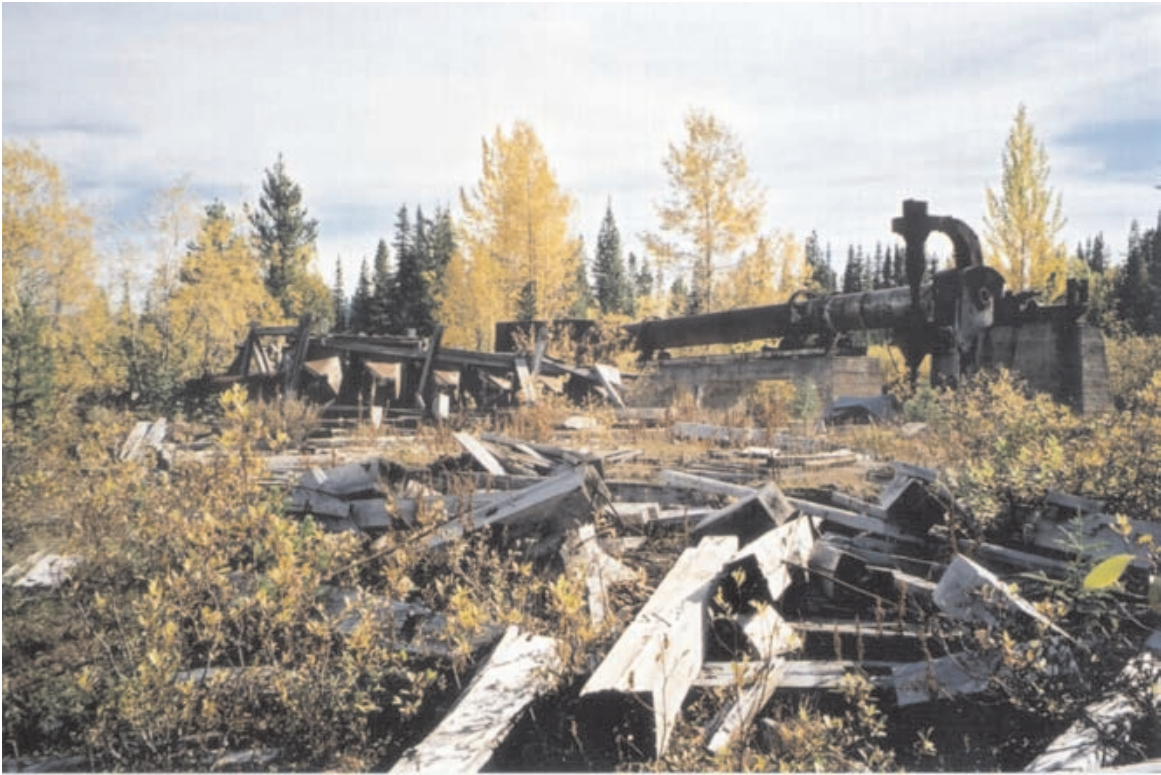
The former smelter is located south of the shaft. The foundation remains. Remnants of equipment include cooling tubes for mercury vapour condensation, a large rotary retort and a cinder brick-lined fire box. The kiln has been removed. Abundant timbers and scrap located at the mill site.

Photo 59. Bralorne Takla mercury mill remains.

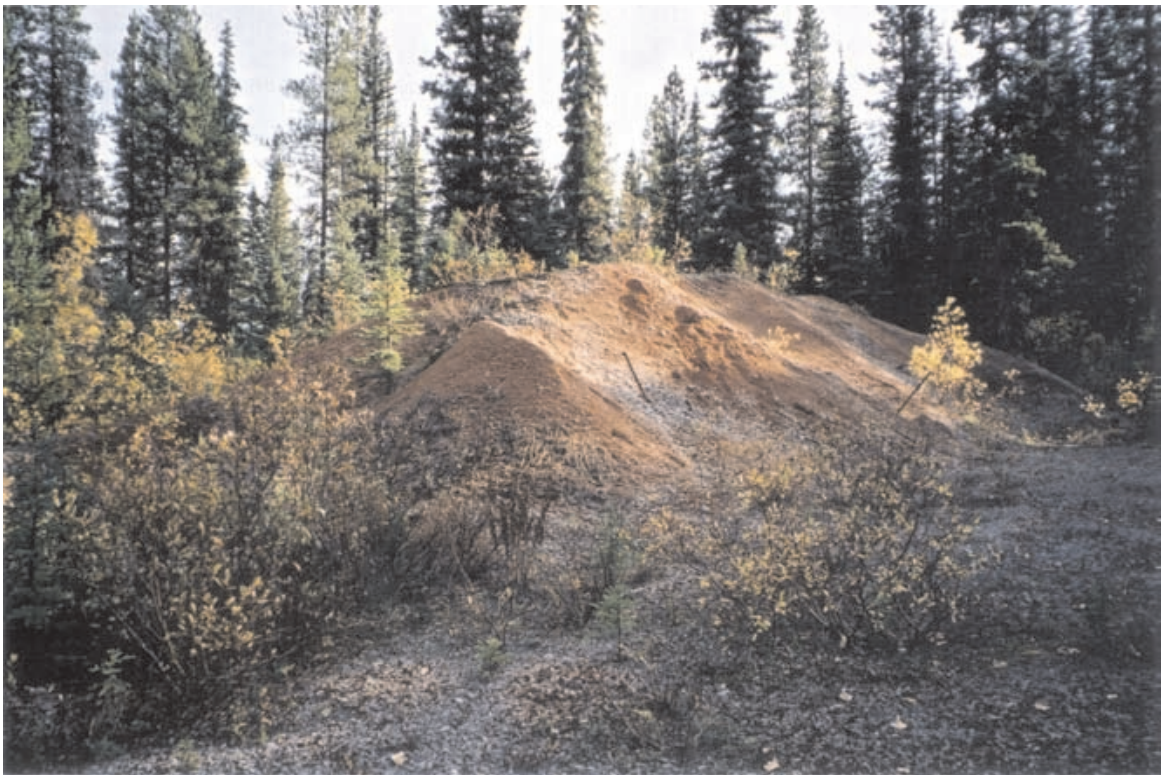
Photo 60. Bralorne Takla

- large concrete foundation due east of primary mine building. Scrap metal and timbers noted.

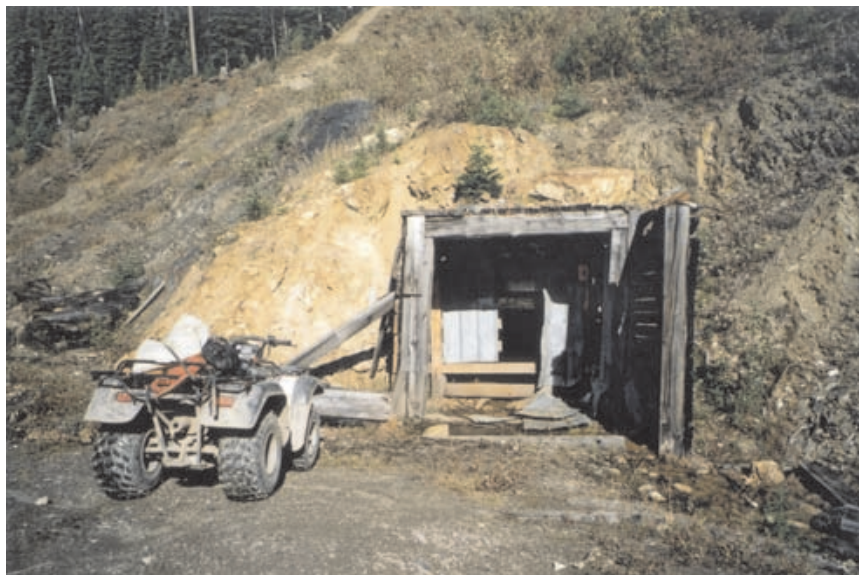
Only one adit was located on the site, which was open and accessible but appeared to be in stable condition. The phyllitic rocks around the collar were weathered an orange-brown colour. Water was draining from the adit but was not sampled.

Photo 63. Cariboo Thompson adit.

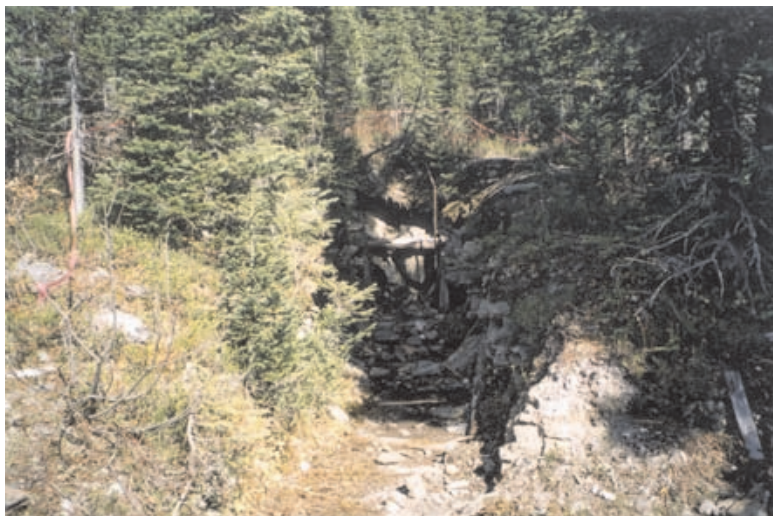
The one portal on site was located at the end of an open cut. The timbered collar was standing but the adit roof had failed. Access was blocked by the collapsed roof rock. The wallrock contained carbonates and was composed of fissile phyllite, schists and quartzites. There was no visible oxidation in outcrop. Water was trickling from the adit and was sampled.

Photo 65. Open cut leading to an adit at the Jim property.

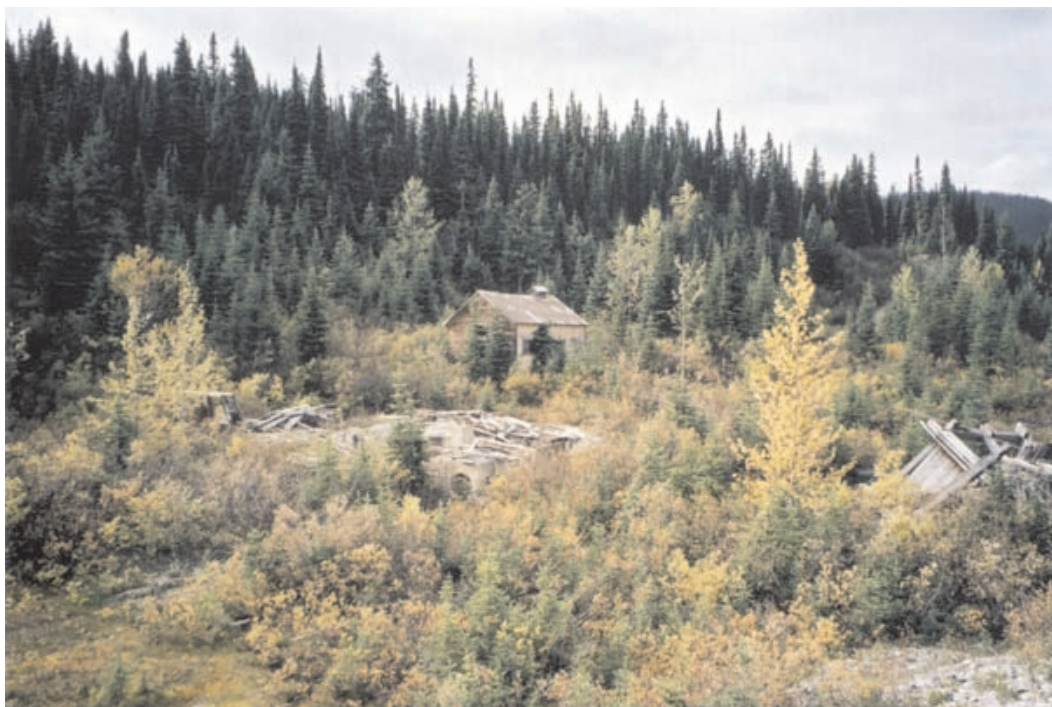
Photo 69. The shaft headframe and buildings (one is collapsed in the foreground) at Canusa mine site.

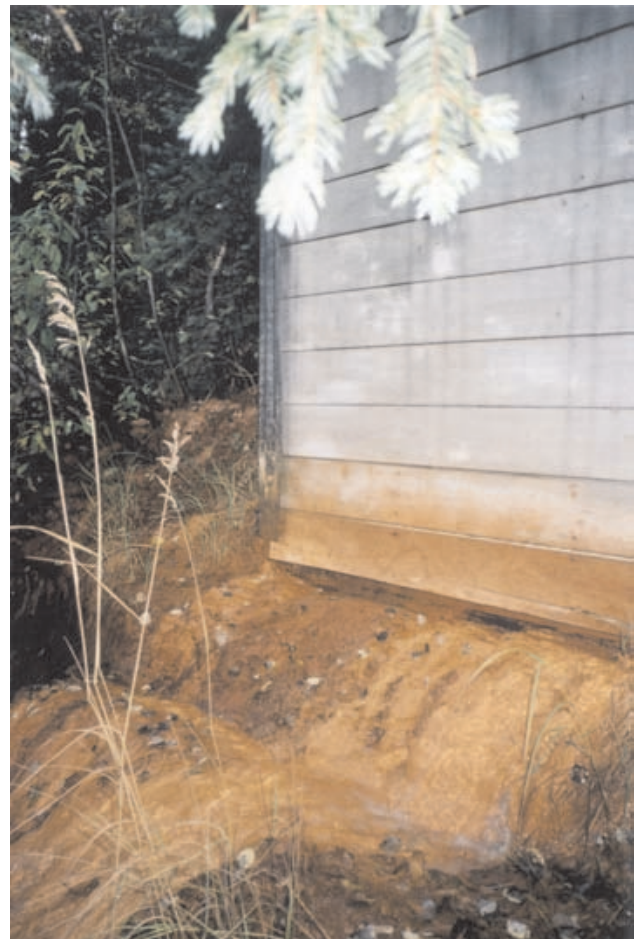
The water draining from the adit with a small building at the portal, flowed through and around the small building and southeast down the slope toward the highway. The red, iron precipitate laden water flowed into a flooded ditch along the northwest side of the highway and to a culvert linking the ditch to Willow River. The end of the culvert draining into

Photo 70. Red drainage flowing from the pump house at Island Mountain.

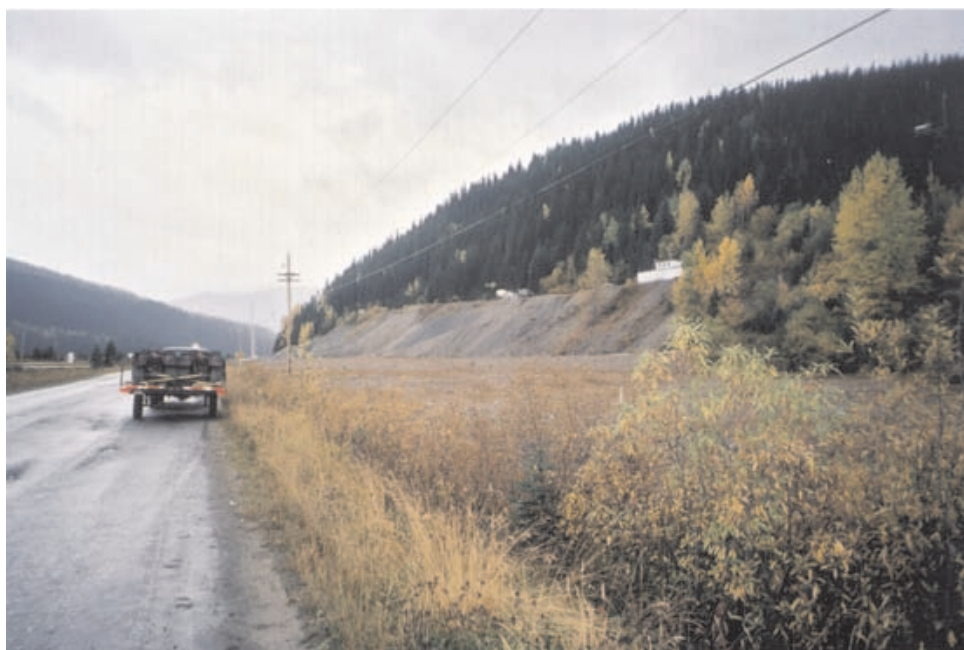
Photo 71. Island Mountain waste rock dump.

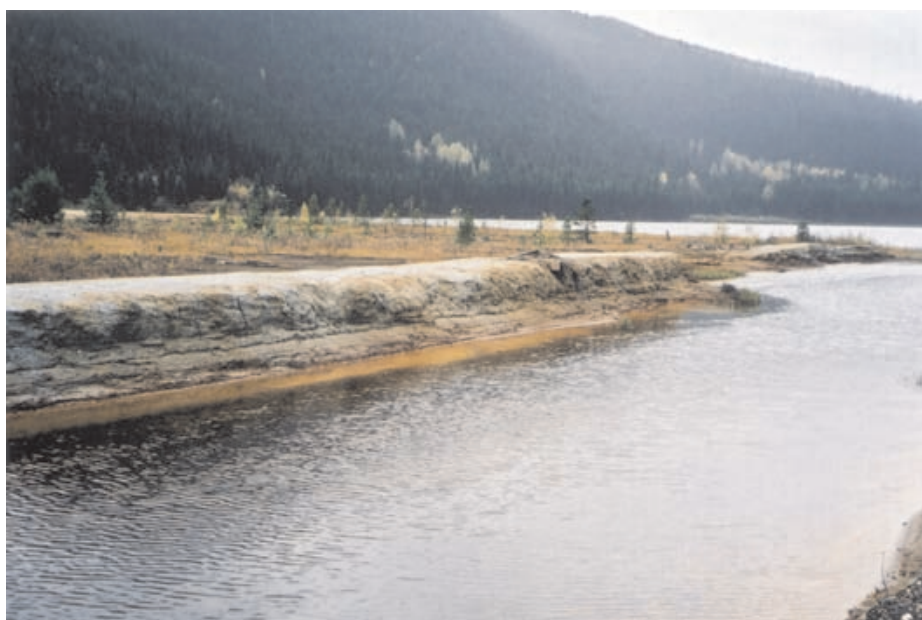
Photo 73. The Cariboo Gold Quartz tailings are submerged in Jack of Clubs Lake and the Willow River. Note the oxidized tailings along the bank of the Willow River.
